PIKEVILLE, TENN.
N3530W8507.5/5
1956
PHOTOFOREVIEW 1977

Landslides and related features interpreted
from aerial photographs:
1:79,000 (Black and White) 1976

Photointerpretation and field check 1981
This report is preliminary and has not
been reviewed for conformity with U.S.
Geological Survey editorial standards.
Additional information from:
Milici, R.C., and Finlayson, C.P., 1967
Geologic map of the Pikeville quadrangle, Tennessee.
Tennessee Department of Conservation,
Division of Geology, scale 1:24,000.

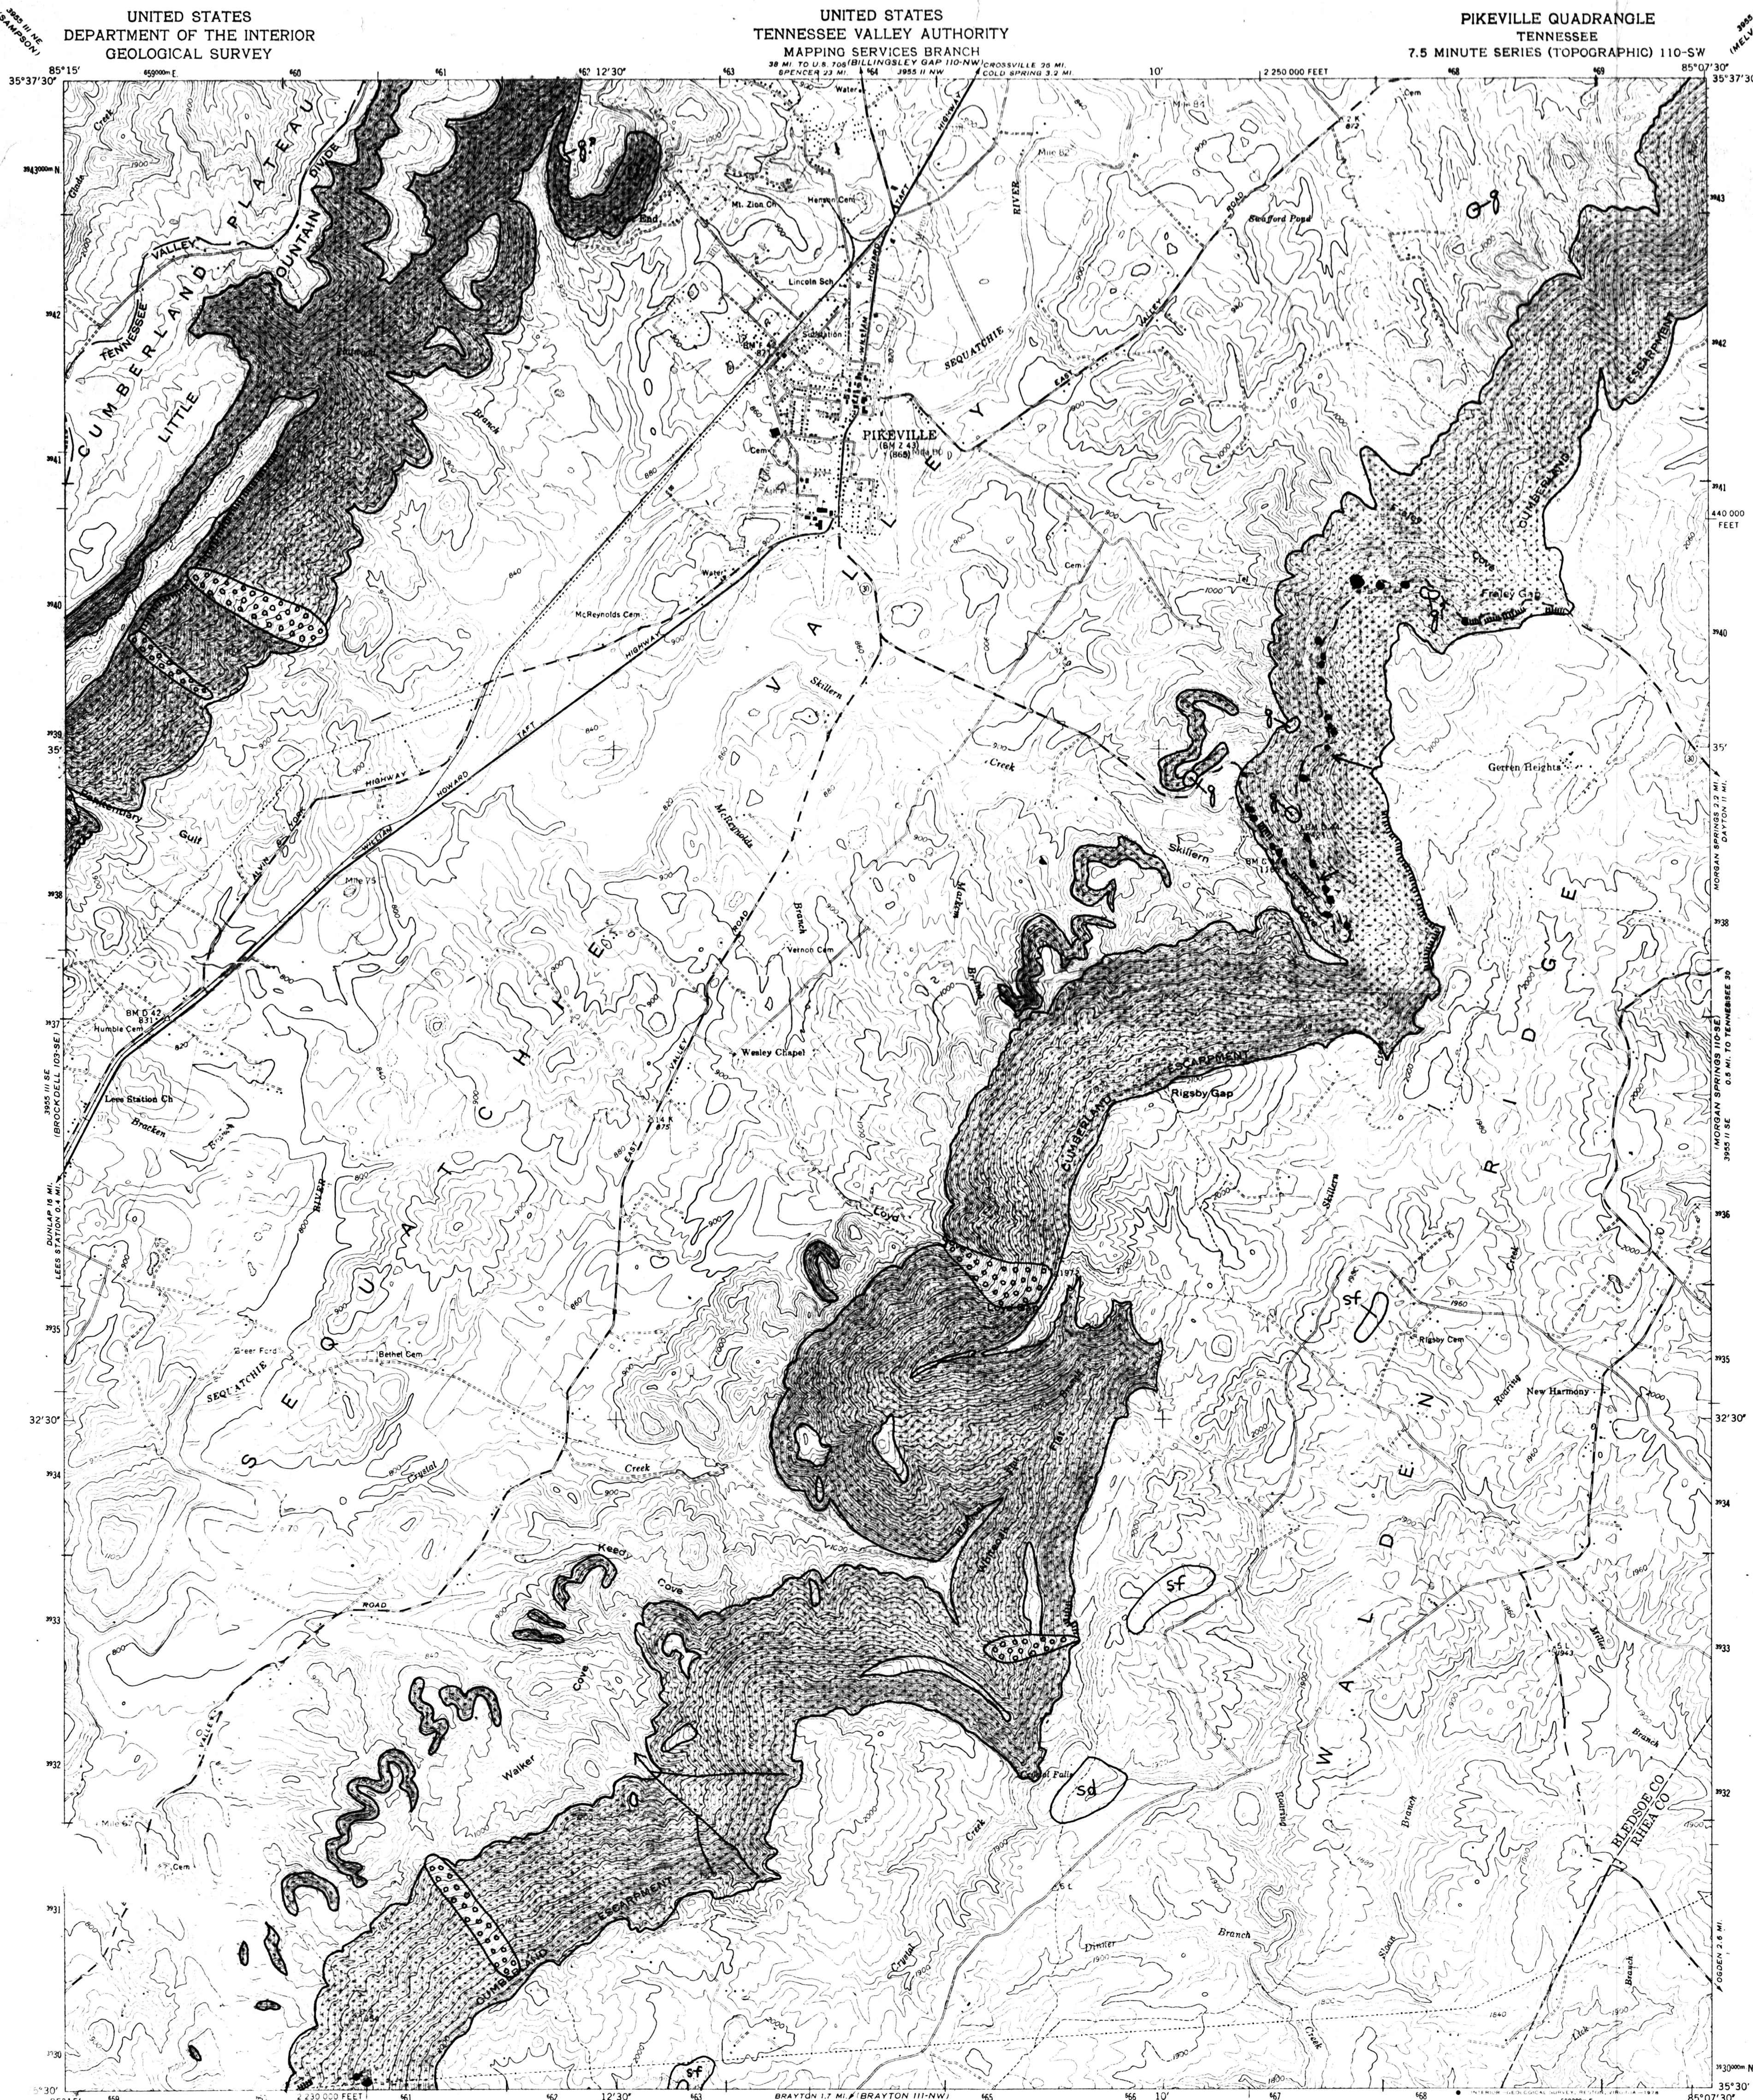
ACTIVE OR RECENTLY ACTIVE LANDSLIDE
Complex landslide composed of earthflow, debris
slide, earth and rock slump. Identified from
historical records, and from scars, debris and
other field evidence. Ground extremely unstable;
sliding accelerated by excavation, loading and
changes in drainage conditions. May include
areas with several active slides too small to
be shown separately. Questioned where doubtful.

OLD LANDSLIDE
Area of extensive hummocky ground caused by
earthflow and earth and rock slump. Lacks
clear evidence of active sliding. Relatively
stable in natural, undisturbed state,
generally not affected by small structures properly
sited in areas away from the edge of the toe;
can be reactivated by extensive, rapid exca-
vation, loading, and changes in ground water and
surface water conditions. Area of old landslide
probably includes recent ones not identified
from field evidence or otherwise documented.
Upslope boundary of landslide generally defined
by modified scarp, but downslope (toe) may be
gradational and not well defined. Questioned
where doubtful.

COLLUVIAL SLOPE
Valley wall along major streams with slope as
steep as 40 (85%); stony, clayey silt soil up
to 50 ft. (15 m) thick; commonly buttressed by
a terrace or bench at the toe of the slope; very
susceptible to sliding by cutting of toe area,
removal of terrace or bench, and overloading;
slide commonly activated without apparent cause.

**AREAS SUSCEPTIBLE TO DEBRIS FLOWS AND DEBRIS
AVALANCHES**
Primarily shallow, narrow ravines and chutes with
accumulation of stony colluvium generally 10 ft.
(3 m) or less in thickness; susceptible to rapid
movement during intense rainfall. Most ravines
and chutes designated show evidence of former
debris flows and avalanches.

AREAS SUSCEPTIBLE TO ROCKFALL
Steep, locally vertical, natural and man-made
slopes and cliffs, 15 ft. (4.5 m) or more high;
formed dominantly of sandstone, limestone, sandy
shale, mudstone and claystone. Interbedded mud-
stone, claystone and shale weather rapidly leaving
sandstone and limestone rock faces unsupported.
